Chapter Nine

Limestone

Nicholas Durnan

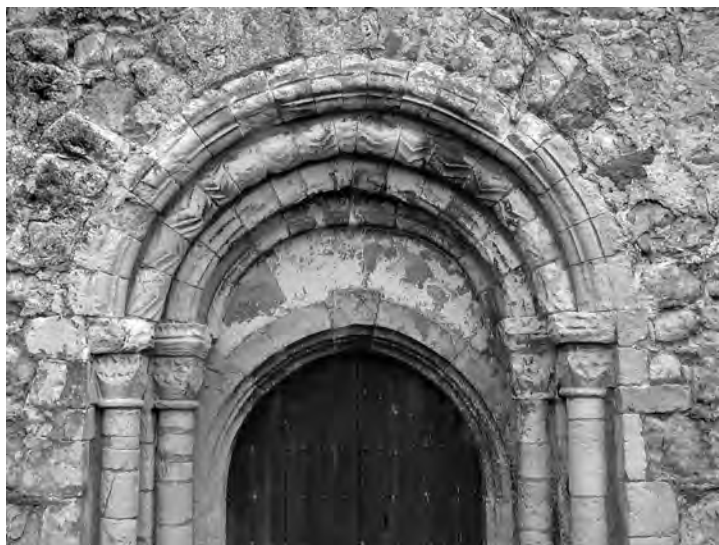
Figure 9.2 A fine twelfth-century west doorway carved in Caen limestone from Normandy, at Ruckinge Church, Kent. The stone exhibits signs of sulphation decay, and soot crusts are collecting in sheltered areas.

The weathering and decay patterns of limestone can be broadly divided into surface decay and deep decay. Sulphation of the calcium carbonate of which limestone is composed leads to salt formation, powdering, blistering, exfoliation and cracking (Figure 9.2). These result in surface distortion and surface loss (Figure 9.3). This can all initially occur to a depth of a few millimetres. In time, these processes can lead to deep decay, where the limestone becomes friable to a depth of at least 50 mm. Deep cracking and delamination can result from chemical and physical change of clay or iron minerals, or simply from poorly selected or incorrectly bedded stone. Surface and deep erosion are often the result of limestone surfaces being inadequately protected from rainwater, perhaps due to being situated in exposed areas of a building. Decay can also be caused by hard, cementitious mortars, which act as moisture traps and often lead to the deterioration of adjacent stone (Figure 9.4).

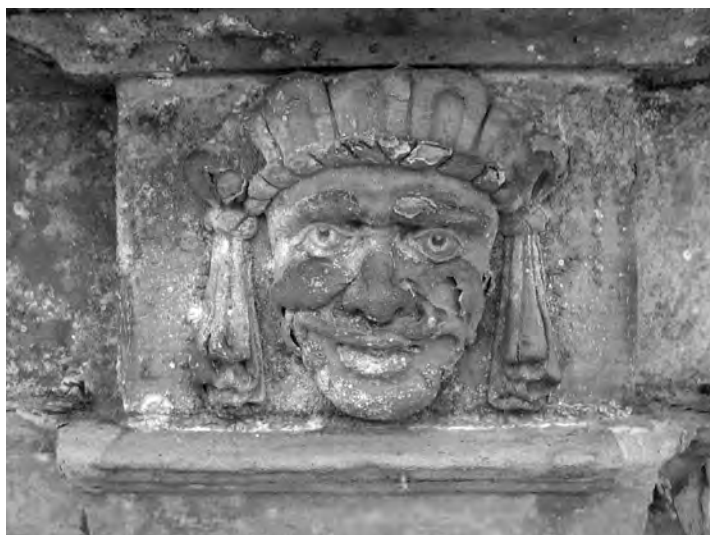
Figure 9.3 A delicately carved eighteenth-century Chilmark limestone mask head, from the façade of Longford Castle, Wiltshire. Facial features have become distorted due to the formation and exfoliation of gypsum skins.

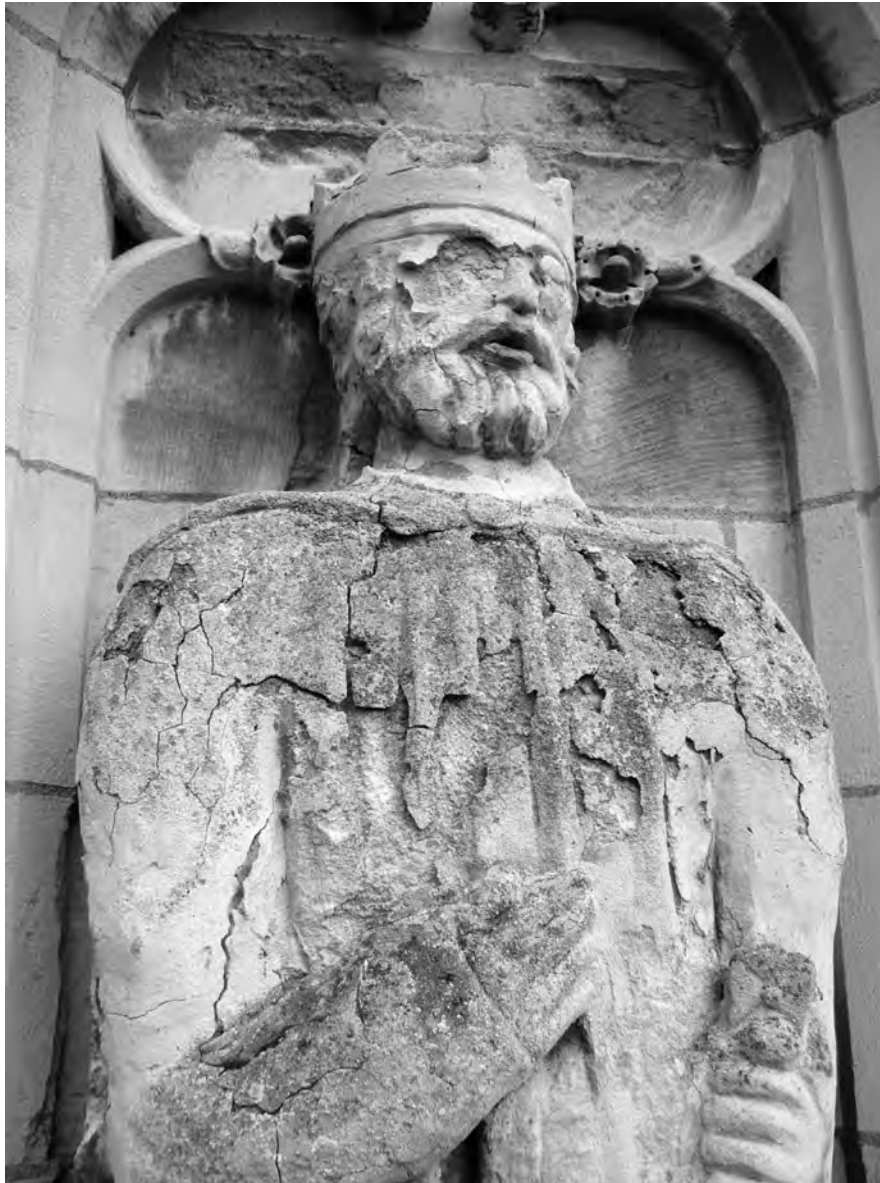
Figure 9.4 Beer limestone statue of Edward the Confessor, early nineteenth century, Exeter Cathedral West Front. There is deep decay under the hard impervious cement repairs, which are cracking and falling away.
