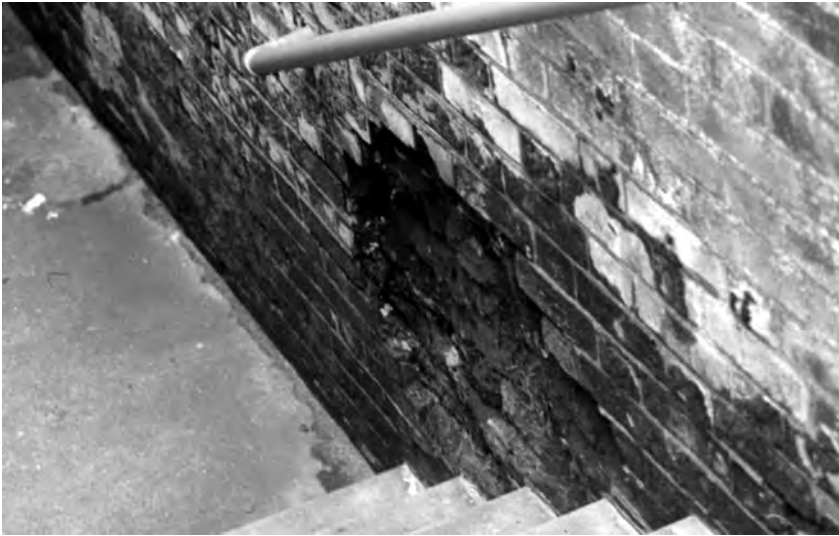
Plate 9.4 Frost damage is usually worst in walls that are permanently soaked.

Frost damage eats into masonry by the action of absorbed water freezing and repeatedly splitting off the face of the unit. Surfaces that are soaked regularly, or hidden behind impermeable render or paint, are most likely to be damaged. Earth-retaining walls of porous masonry with no damp-proof membrane are particularly vulnerable; so are water-collecting projections and ledges, as well as masonry which is accidentally soaked by faulty rainwater goods or traffic splashing. Water from melting snow has least chance of evaporating before the next freeze cycle, and most chance of doing damage. Parapets, chimneys and walls that trap snow (Figure 7.3, page 86) will attract this particular risk. In one case, a chimney was built of frost-resistant bricks above the roof line but of frost-susceptible bricks below, and frost damage within the roof space became serious enough to cause instability. The damage had been caused by water percolating downwards and then freezing within the roof space.

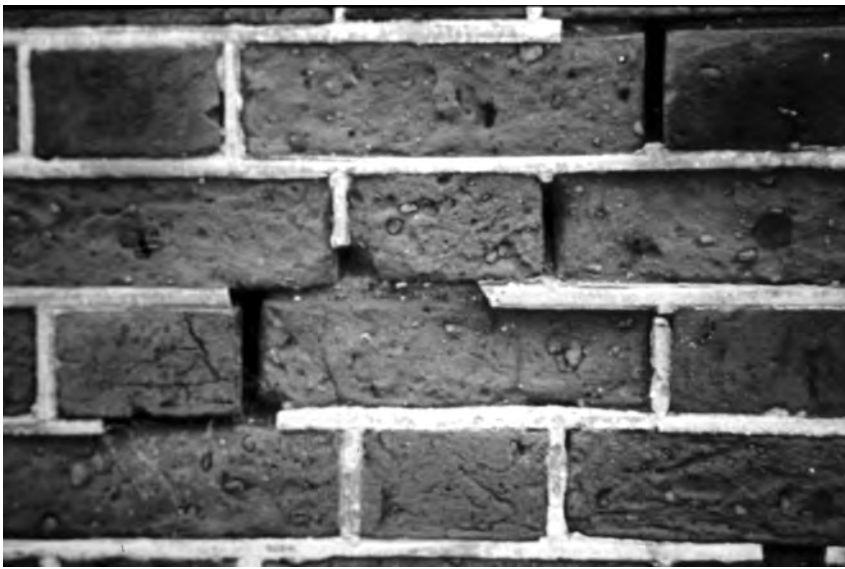
Plate 9.5 Frost damage can be exacerbated by hard cement pointing, which traps water that would otherwise drain into mortar joints and evaporate outwards harmlessly. The delay provides more opportunity for the water to freeze and split away the faces of the bricks.

Frost damage is sometimes the unintended result of repointing. If the material used is cement-rich, as it so often is, the mortar beds become suddenly dammed by their new impermeable face. Water no longer
