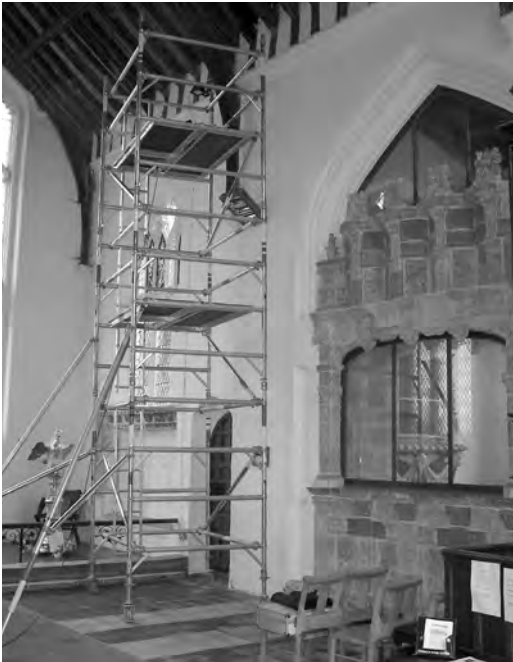
Figure 5.1a Scaffold tower used for inspection of church roof structure. Safety considerations include use of fully extended outriggers, locked wheel castors, fixed internal access ladder and platform trapdoors. Protection should be provided beneath wheel castors where there is a risk of damage to floor surfaces

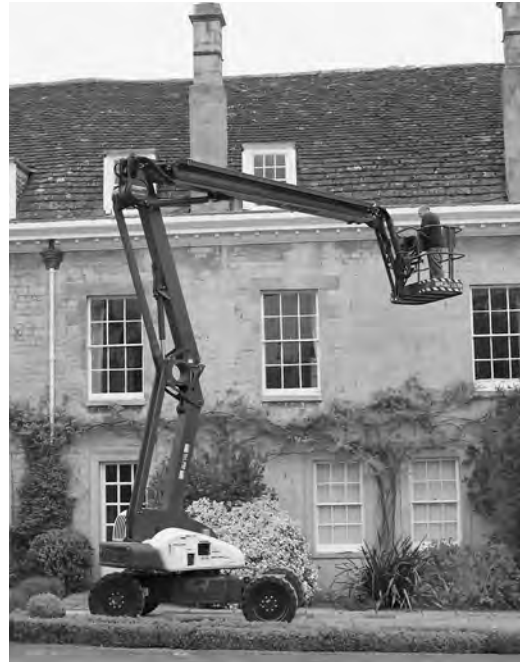
Figure 5.1b Powered-access platform used for inspection and maintenance tasks to chimney stacks and rainwater goods. With a maximum working height of 21.2 m, unrestricted working outreach of 13.2 m and gross vehicle weight of 6.1 tonnes, this platform could be driven across a paved terrace with reduced risk of damage to poorly supported stone paving slabs.

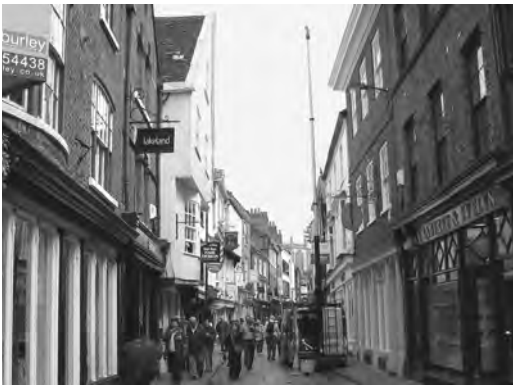
Figure 5.1c Telescopic mast-mounted camera used to record high-level fabric in a restricted urban setting (Credit: Aerial Viewpoint).

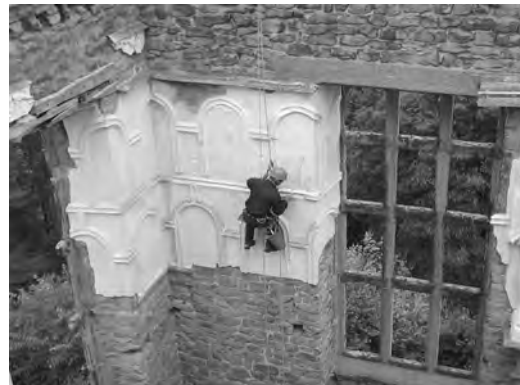
Figure 5.1d Inspection of cracking in the now floorless Great Hill Hall at Hardwick Old Hall (Derbyshire) as part of a full assessment of plasterwork condition (Credit: Joe Picalli of Conservation Solutions).

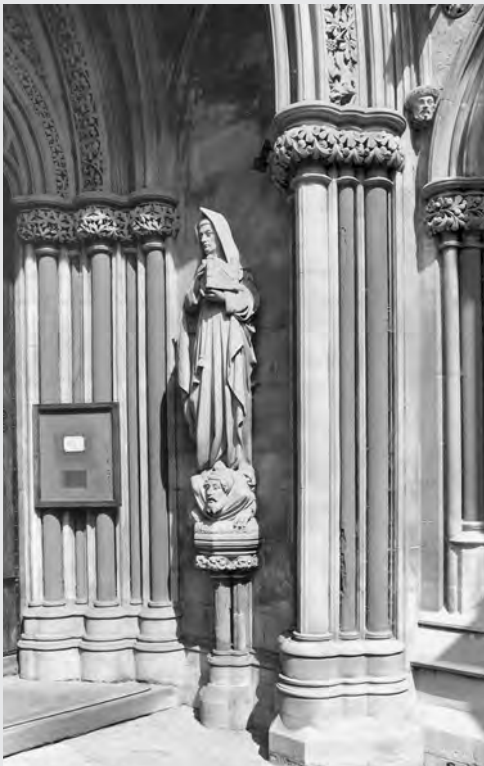
Figure 9.12 The Mansfield red dolomitic sandstone chosen by Sir George Gilbert Scott for the tall one-piece shafts to St John's College Chapel, Cambridge (1866–69) failed. The reason for this was that the stone had to be used with the bedding planes set vertically due to the shallow stratum from which the stone was taken.

- Incorrect selection of stone for use and/or location (Figure 9.12).
- Inherent weaknesses, such as soft clayey or poorly bound beds.
- Moisture retained by mosses and lichens, causing localized saturation and staining.
- Build-up of droppings from feral pigeons. Chemical compounds within the faeces can attack the stone.
- Atmospheric pollution, including tars and chemical compounds, can lead to surface deposits that block the pores of the stone and attack calcite binders. The effects of historic pollution from industrial sources often still prevail with continuing decay (sometimes referred to as the 'memory effect'), while current problems relate typically to vehicle emissions. Limestones and sandstones

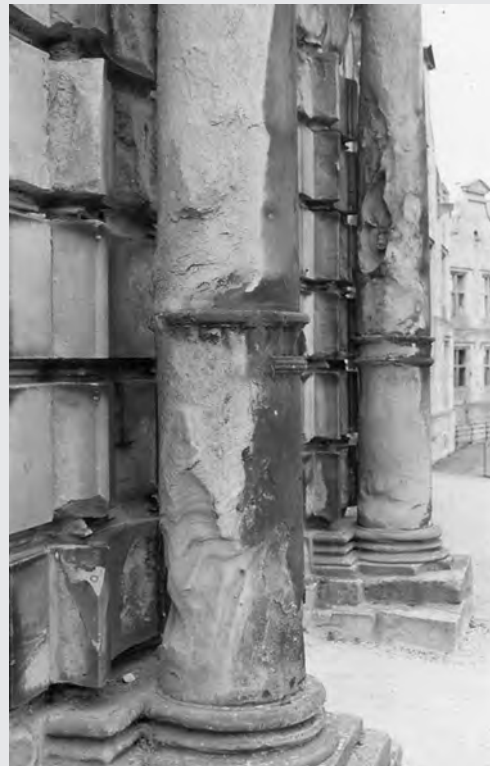
Figure 9.13 Contour scaling of sandstone caused by atmospheric pollution and cycles of wetting and drying.
